**PHASE I MILESTONE INSPECTION FOR**

**BENT PALM CLUB CONDOMINIUM**

**935 OCEAN SHORE BLVD  
ORMOND BEACH 32176**

Bent Palm Club Condominiums  
935 Ocean Shore Blvd – Ormond Beach, FL 32176  
Phase I Milestone Inspection - FL Statute 553.899 & 718.112  
CRA & Associates, Inc. Job ID#: 23-1136

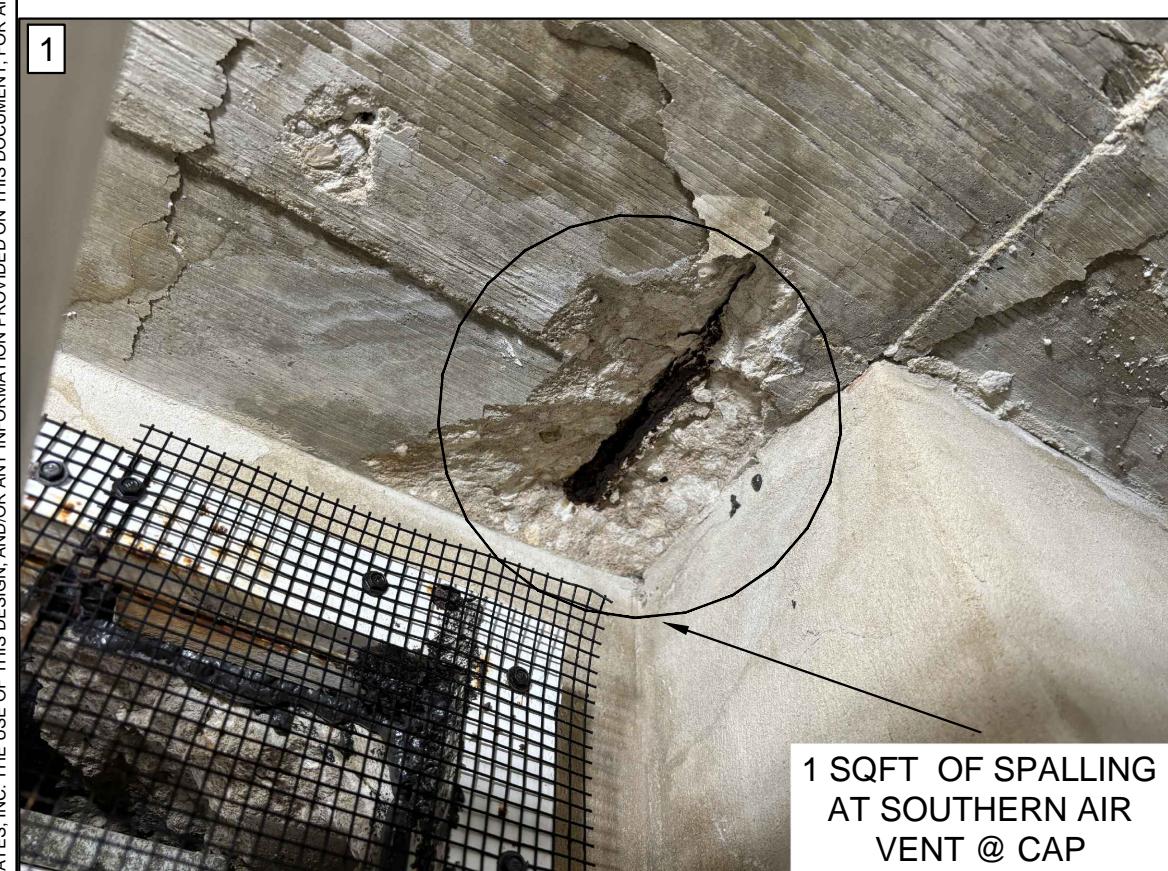
1 SQFT OF SPALLING  
AT SOUTHERN AIR  
VENT @ CAP

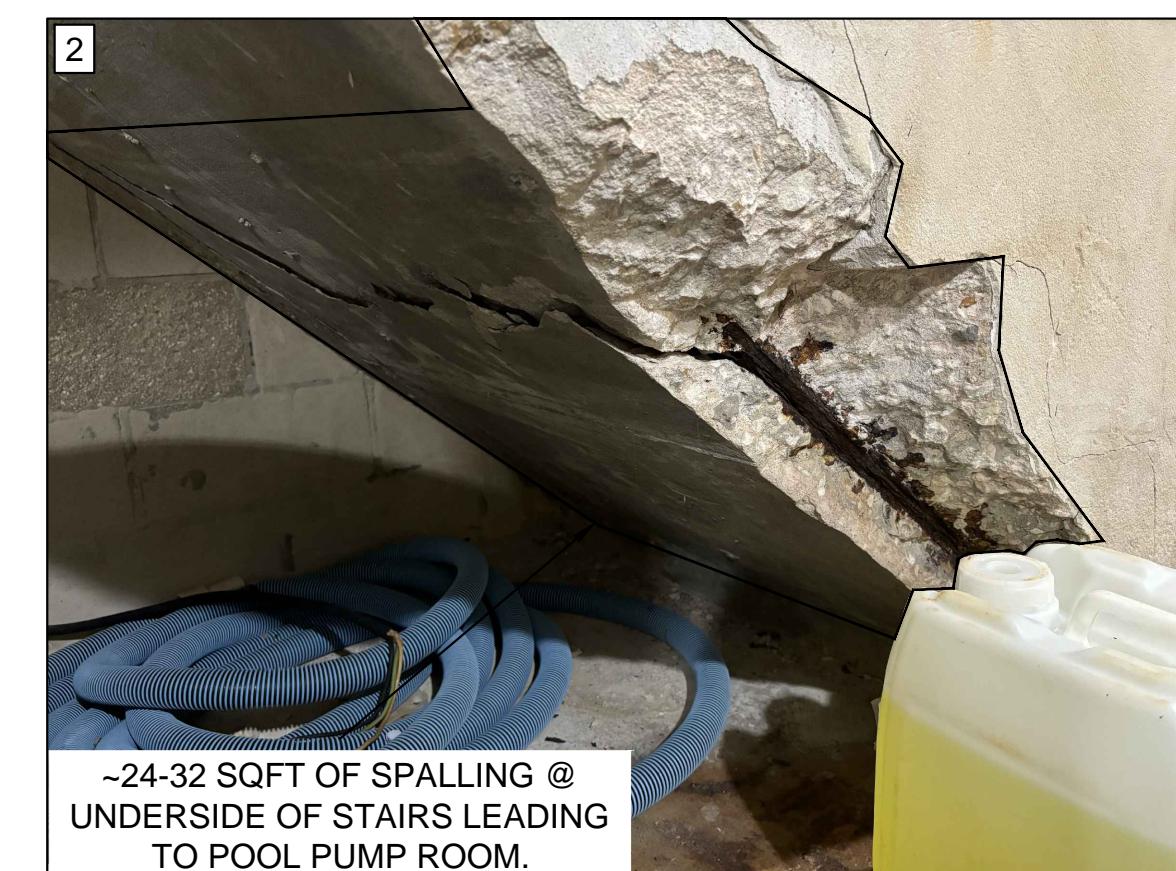
-24-32 SQFT OF SPALLING @  
UNDERSIDE OF STAIRS LEADING  
TO POOL PUMP ROOM.
