**PHASE I MILESTONE INSPECTION FOR**

**BENT PALM CLUB CONDOMINIUM**

**935 OCEAN SHORE BLVD  
ORMOND BEACH 32176**

Bent Palm Club Condominiums  
935 Ocean Shore Blvd – Ormond Beach, FL 32176  
Phase I Milestone Inspection - FL Statute 553.899 & 718.112  
CRA & Associates, Inc. Job ID#: 23-1136

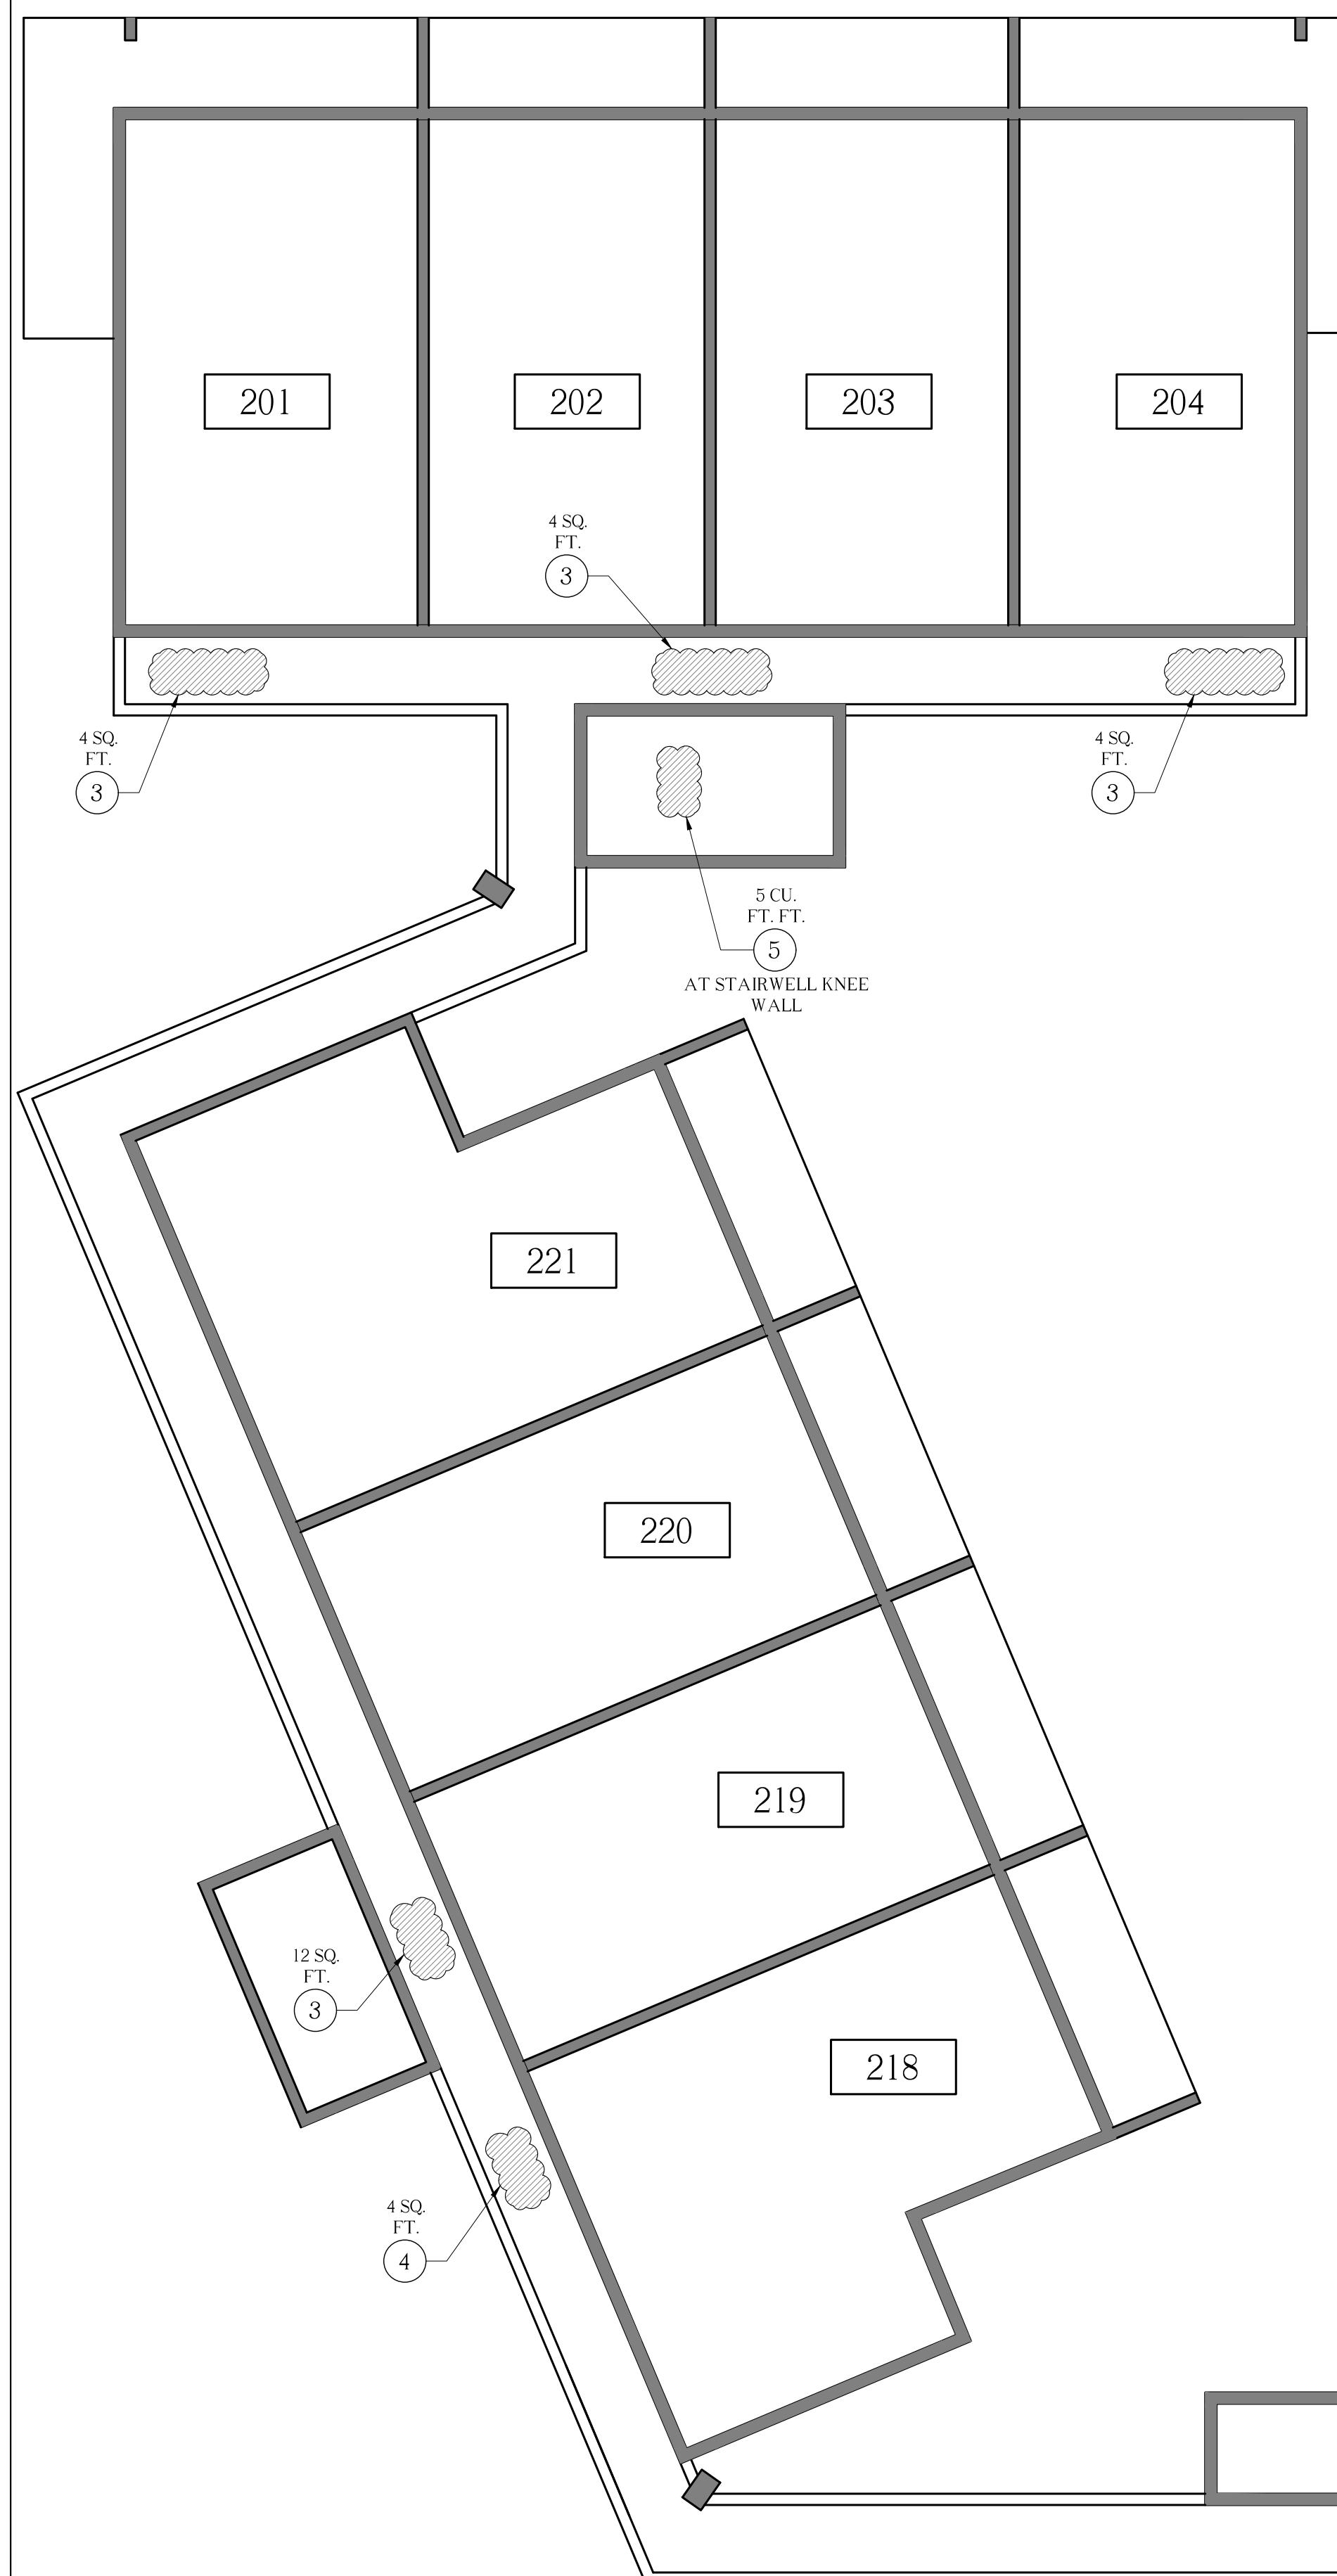
REPAIR DESCRIPTION	
1.	CORNER REPAIR
2.	EDGE REPAIR
3.	DECK SURFACE REPAIR
4.	SOFFIT/CEILING REPAIR
5.	VERTICAL SURFACE/COLUMN REPAIR
6.	BEAM REPAIR
7.	BEAM REPAIR
8.	FULL DECK REPLACEMENT
9.	RAIL POST JOINT REPAIR
10.	CONCRETE CRACK REPAIR (COSMETIC)

QUANTITIES	
±	40 LF. OF CRACK REPAIR
±	4 SQ. FT. OF SOFFIT REPAIR
±	5 CU. FT. OF VERT. SURFACE REPAIR
±	45 SQ. FT. OF DECK SURFACE REPAIR

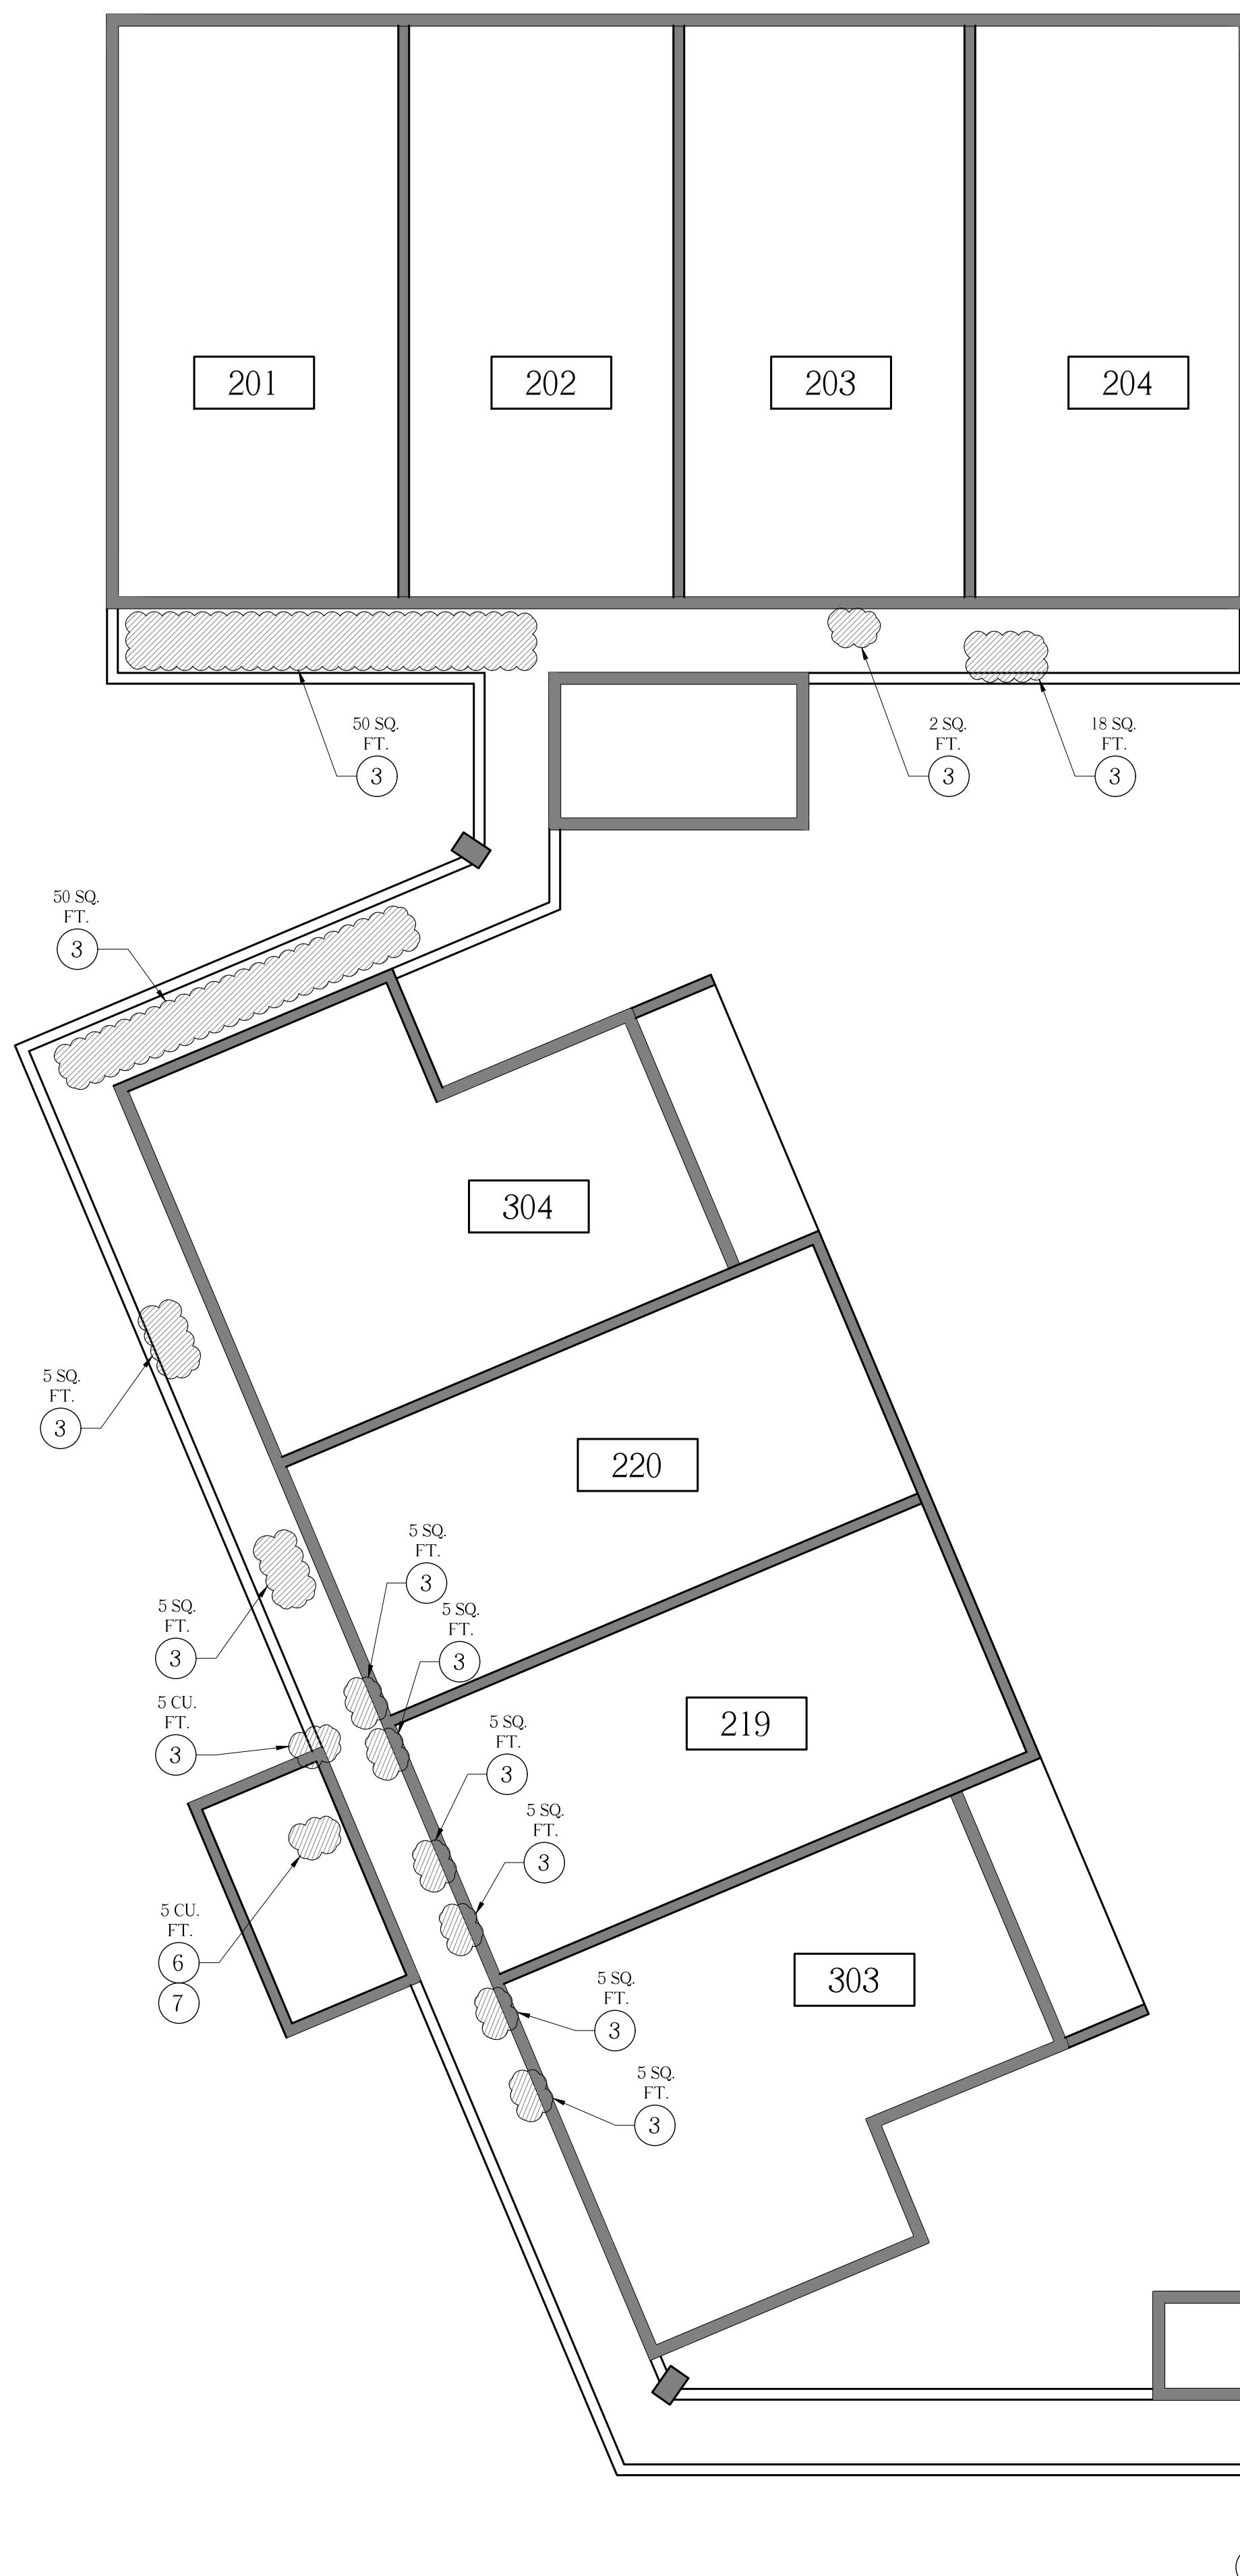
1. CORNER REPAIR
2. EDGE REPAIR
3. DECK SURFACE REPAIR
4. SOFFIT/CEILING REPAIR
5. VERTICAL SURFACE/COLUMN REPAIR
6. BEAM REPAIR
7. BEAM REPAIR
8. FULL DECK REPLACEMENT
9. RAIL POST JOINT REPAIR
10. CONCRETE CRACK REPAIR (COSMETIC)

- ± 40 L.F. OF CRACK REPAIR
- ± 10 SQ. FT. OF SOFFIT REPAIR
- ± 14 CU. FT. OF VERT. SURFACE / COLUMN REPAIR
- ± 220 SQ. FT. OF DECK SURFACE REPAIR

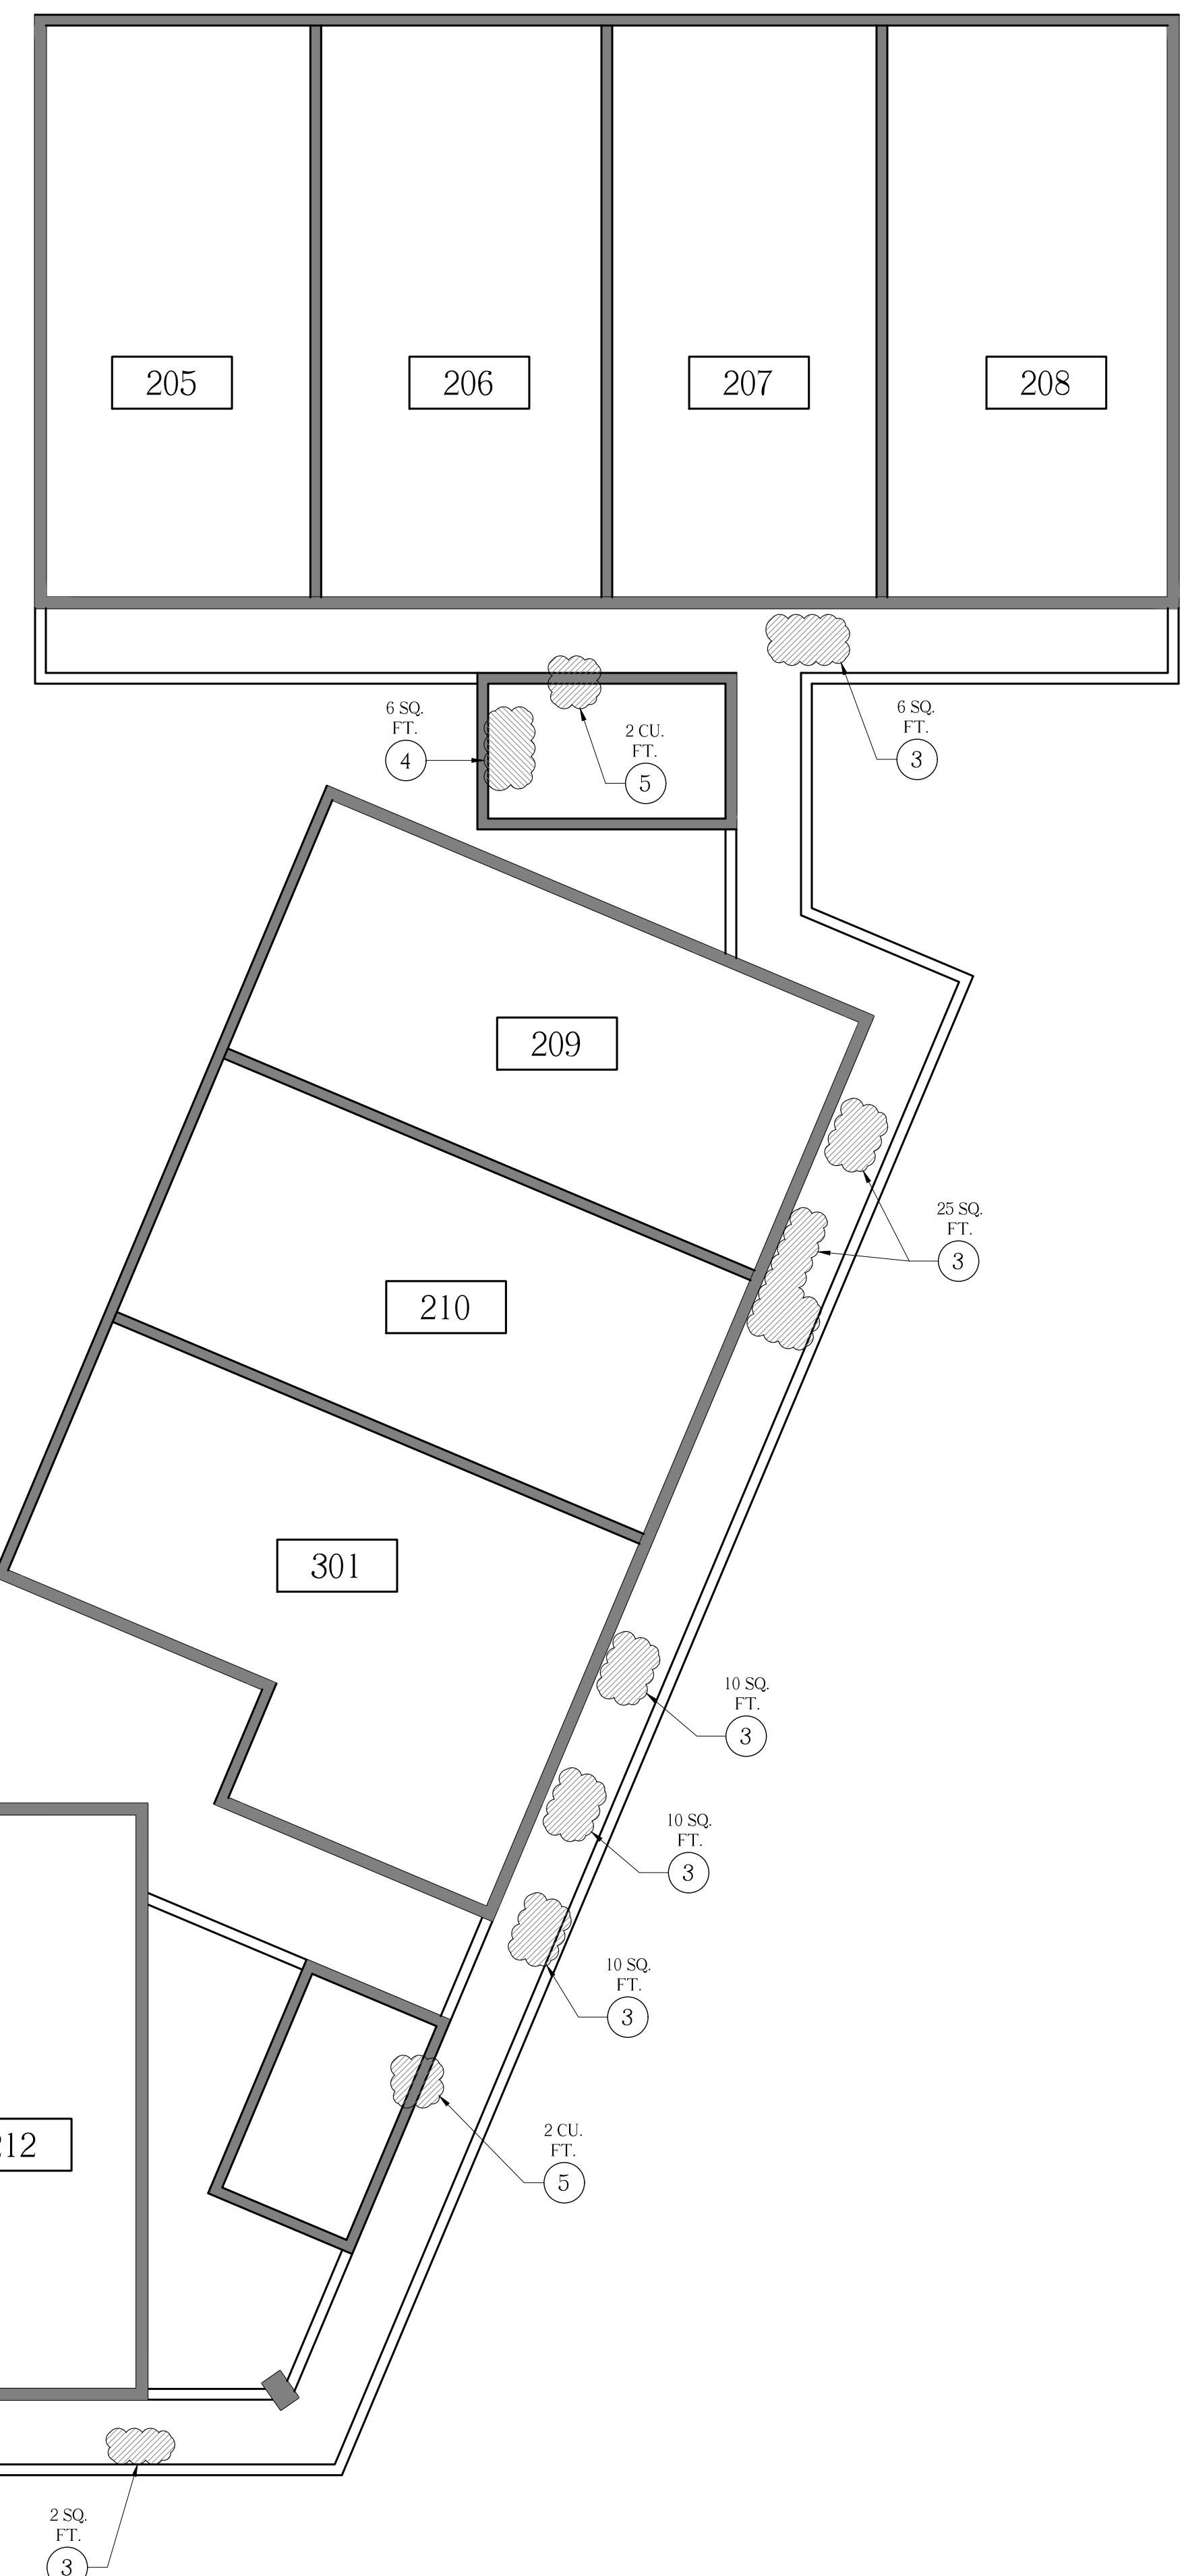
3rd Floor Repair Plan

1. CORNER REPAIR
2. EDGE REPAIR
3. DECK SURFACE REPAIR
4. SOFFIT/CEILING REPAIR
5. VERTICAL SURFACE/COLUMN REPAIR
6. BEAM REPAIR
7. BEAM REPAIR
8. FULL DECK REPLACEMENT
9. RAIL POST JOINT REPAIR
10. CONCRETE CRACK REPAIR (COSMETIC)

- ± 4 SQ. FT. OF SOFFIT REPAIR
- ± 10 SQ. FT. OF DECK SURFACE  
REPAIR

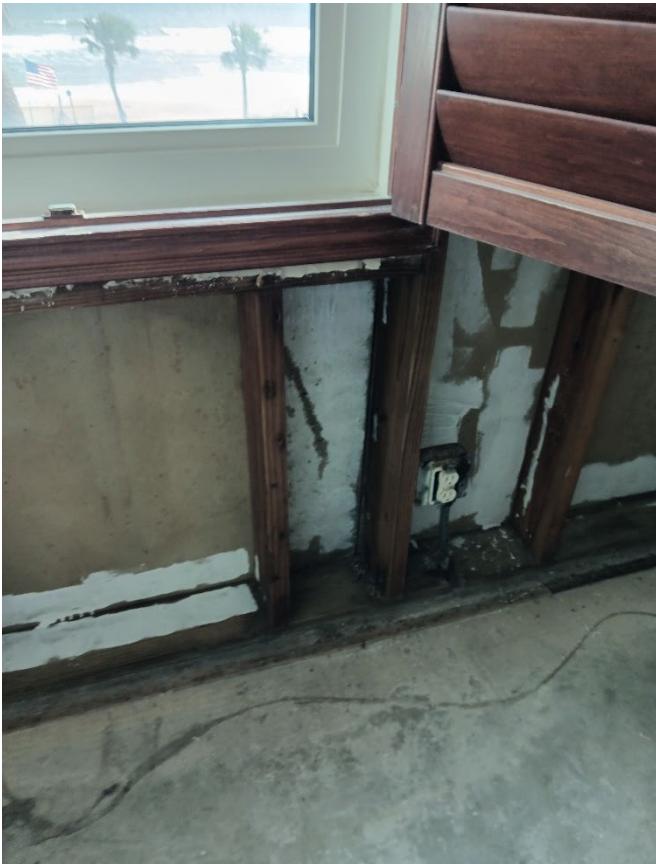
Location of Water Intrusion (1)

We also inspected east facing areas on the 4<sup>th</sup> floor in the west building, north most unit. There were signs of previous water intrusion, and there was an attempt to deduce the cause of this moisture penetration. We verified that the DensGlass siding was properly installed, and likely not the cause of water intrusion. It is meant for exterior use and exposure to moisture will not cause it to fail like drywall. In addition, we inspected the window, which appeared to be properly installed, with an embedment of caulking around the frame, caulking on the fasteners, and caulking around the perimeter. There was a significant area of damage at the soffit above this unit, and the roof had several deficiencies, according to R & J Coatings. It is likely that during the recent Hurricane, water was forced in through the weep holes and penetrated the wall framing. This is not a major concern, due to the fact that it was likely caused by adverse weather conditions, and not regular exposure. If this condition persists, we recommend repairing the obvious damages first, such as the roof, and the soffit. If this does not yield results, then we recommend hiring a leak detection or thermal imaging inspector to see if they can narrow down the location of the leak. In addition to this, it would be prudent to re-caulk the windows and, if necessary, have the windows removed and bedded in caulk again.

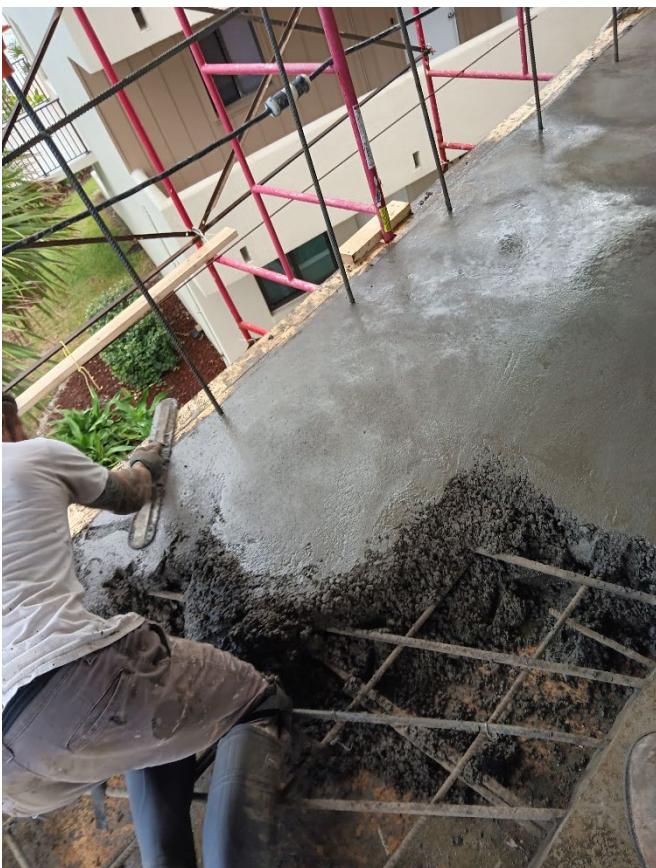
Repairs Underway (1)

As of the time of this inspection, repair was underway at the northwest building's 3<sup>rd</sup> floor elevated walkway. Demolition was complete, shoring was properly placed, reinforcing was properly supplemented, tied, & treated, and formwork was properly installed. Concrete placement was underway during our inspection. The mix was properly hydrated, and the installation was being properly executed, with concrete being forced into the corners of the formwork, and the surface being screeded and floated to achieve a level and smooth finish.

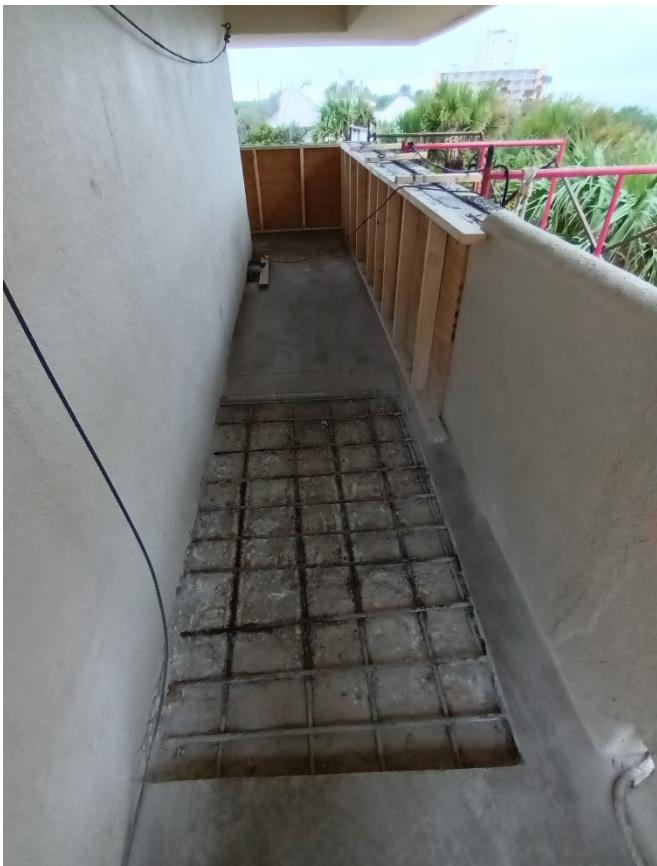
Repairs Underway (1)

As of the time of this inspection, repair was underway at the northwest building's 3<sup>rd</sup> floor elevated walkway. Concrete placement was complete for the elevated walkway, and concrete had just been poured for the knee wall. There were miscellaneous other repairs demolished and prepped on the northwest building's 3<sup>rd</sup> floor elevated walkway. We approved additional concrete placement at the contractor's earliest convenience.

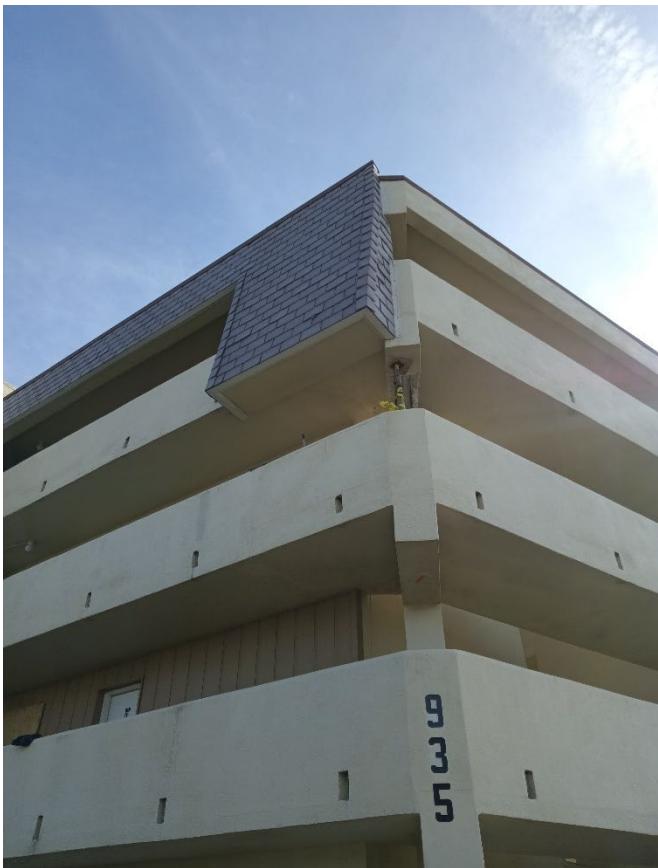
Repairs Underway (1)

As of the time of this inspection, repair was underway at the northwest building's 3<sup>rd</sup> floor elevated walkway. Additional concrete placement was complete for the elevated walkway, and additional concrete had just been poured for the knee wall. There were miscellaneous other repairs demolished and prepped on the northwest building's 3<sup>rd</sup> & 2<sup>nd</sup> floor elevated walkways. We approved additional concrete placement, upon the completion of further preparation work, at the contractor's earliest convenience.

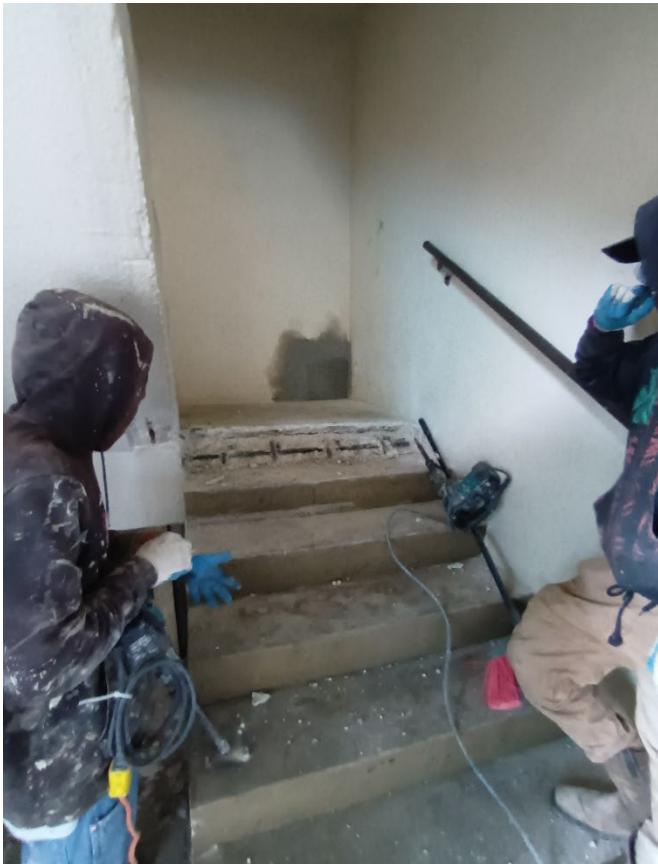
Repairs Underway (1)

As of the time of this inspection, repair was underway at the southwest building's 2<sup>nd</sup> & 3<sup>rd</sup> floor elevated walkways. There were miscellaneous other repairs demolished and prepped on the southwest building's elevated walkways. We approved additional concrete placement, upon the completion of further preparation work, at the contractor's earliest convenience.

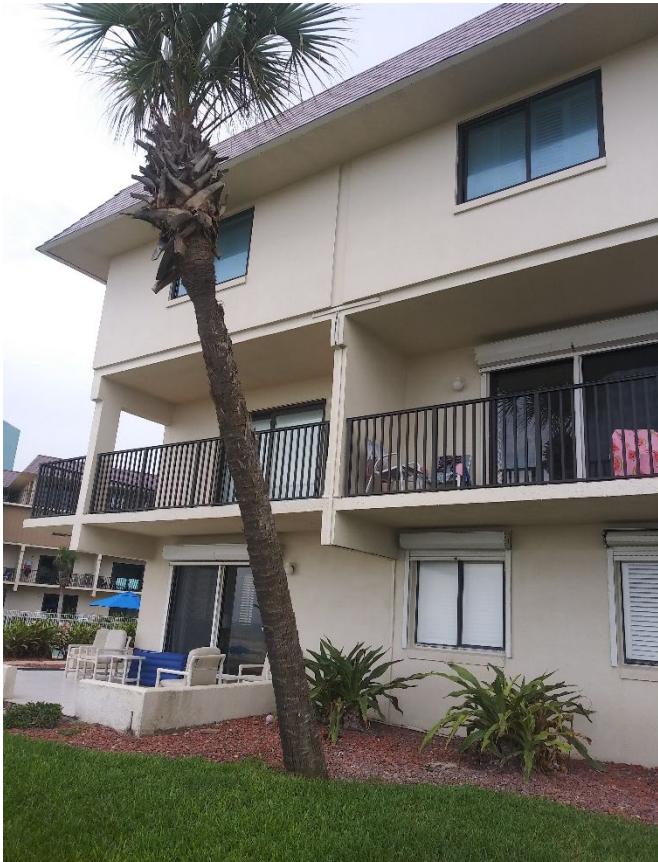
Completed Repairs Units 203-204

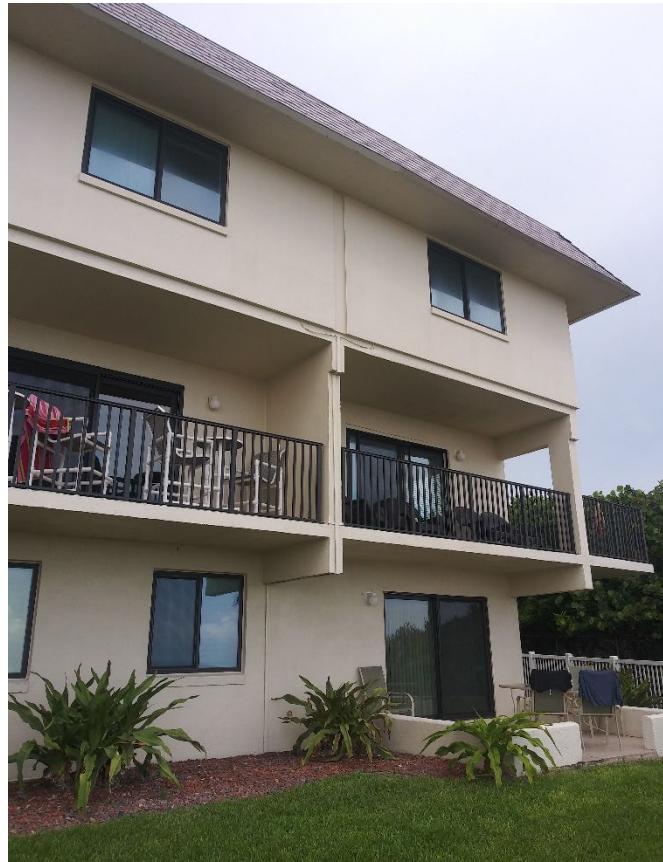
Completed Repairs Units 201-202

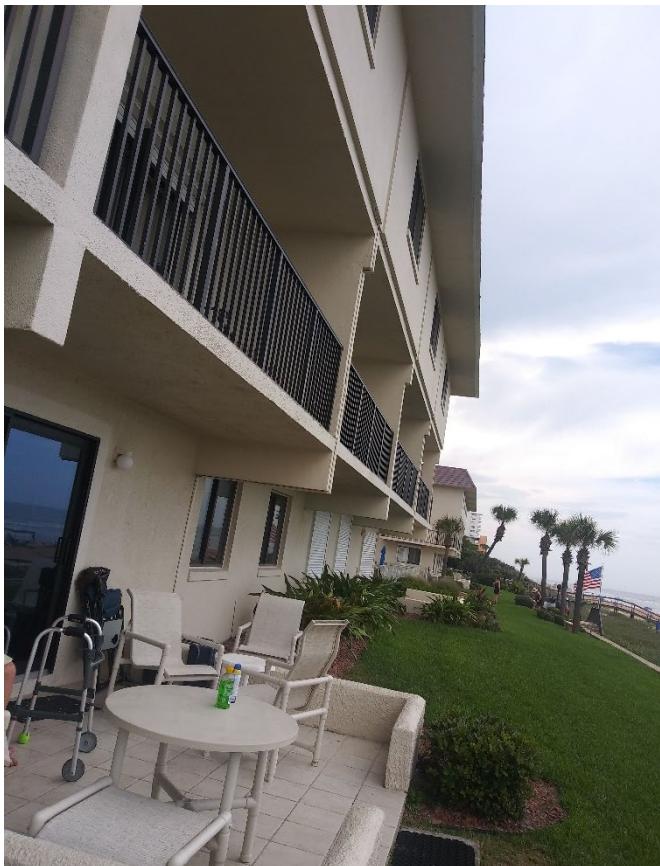
**Completed Repairs Units 208-201**

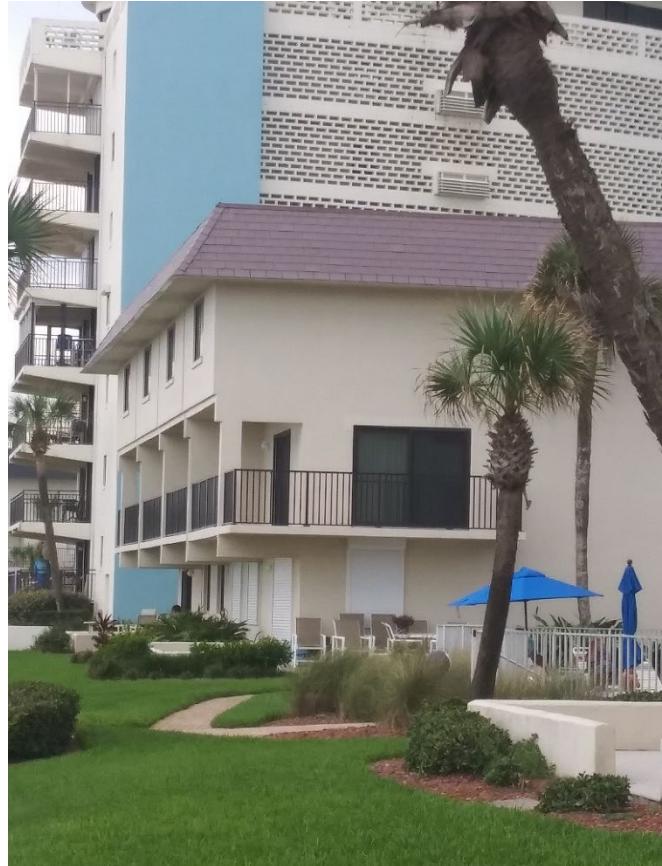
**Completed Repairs Units 205-208**

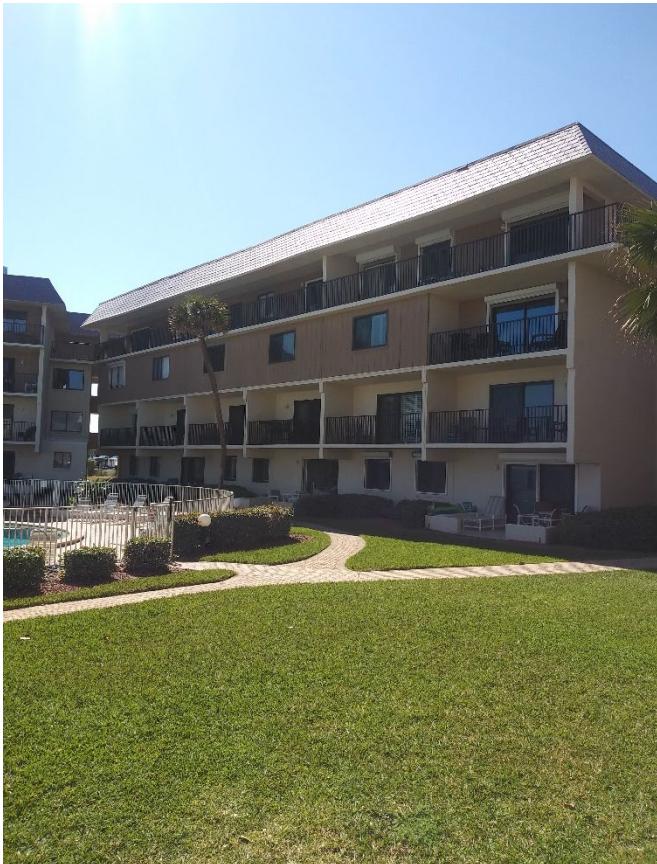
Completed Repairs Units 209-221 (1)

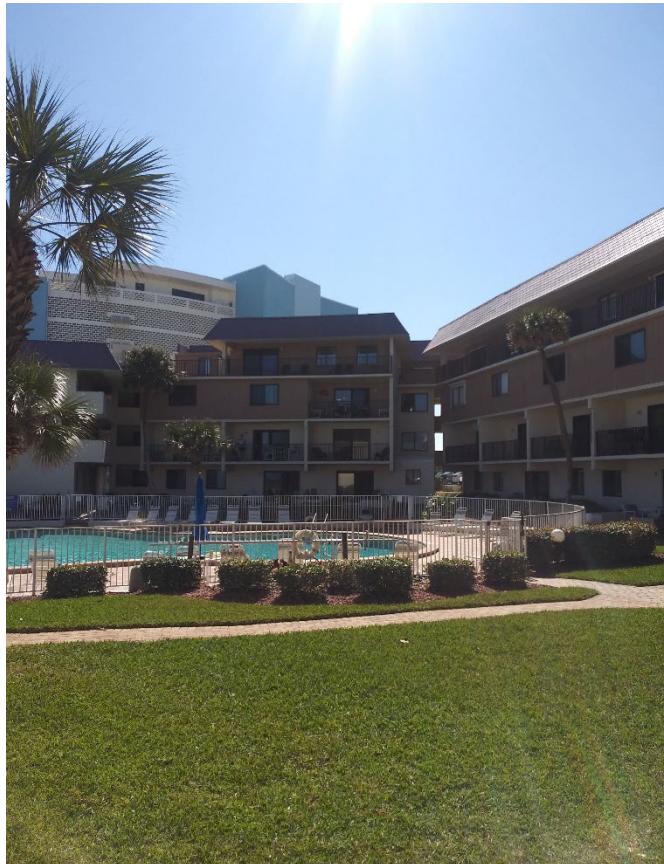
Completed Repairs Units 209-221 (2)

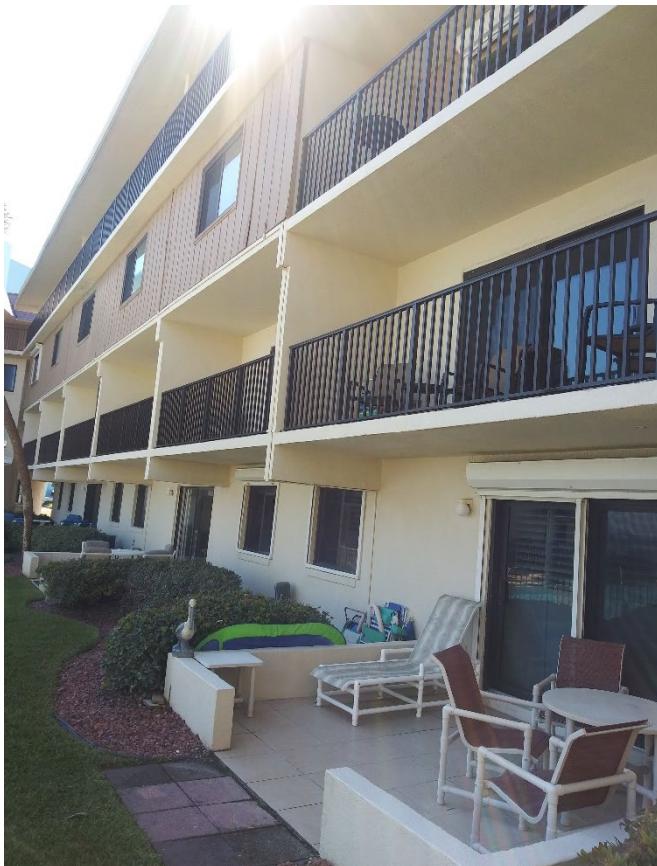
Completed Repairs Units 209-221 (3)

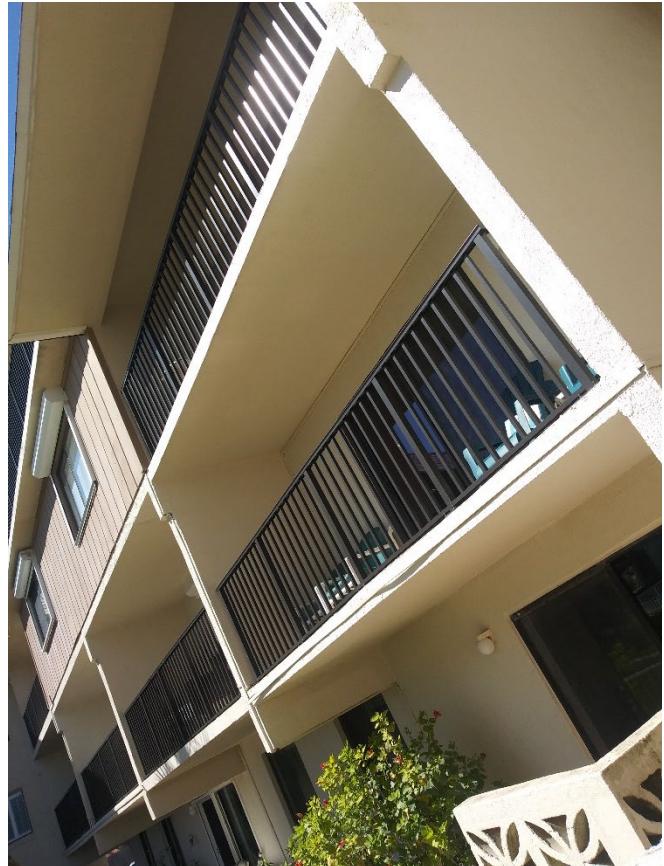
Completed Repairs Units 209-221 (4)
